**TRACY MUNICIPAL AIRPORT
PAVEMENT EVALUATION STUDY
PAVEMENT MAINTENANCE/MANAGEMENT PLAN**

**Appendix C
Pavement Condition Survey**

TRACY MUNICIPAL AIRPORT
 CALIFORNIA
PAVEMENT EVALUATION
 SURFACE DISTRESS - PAVEMENT CONDITION INDEX (PCI)

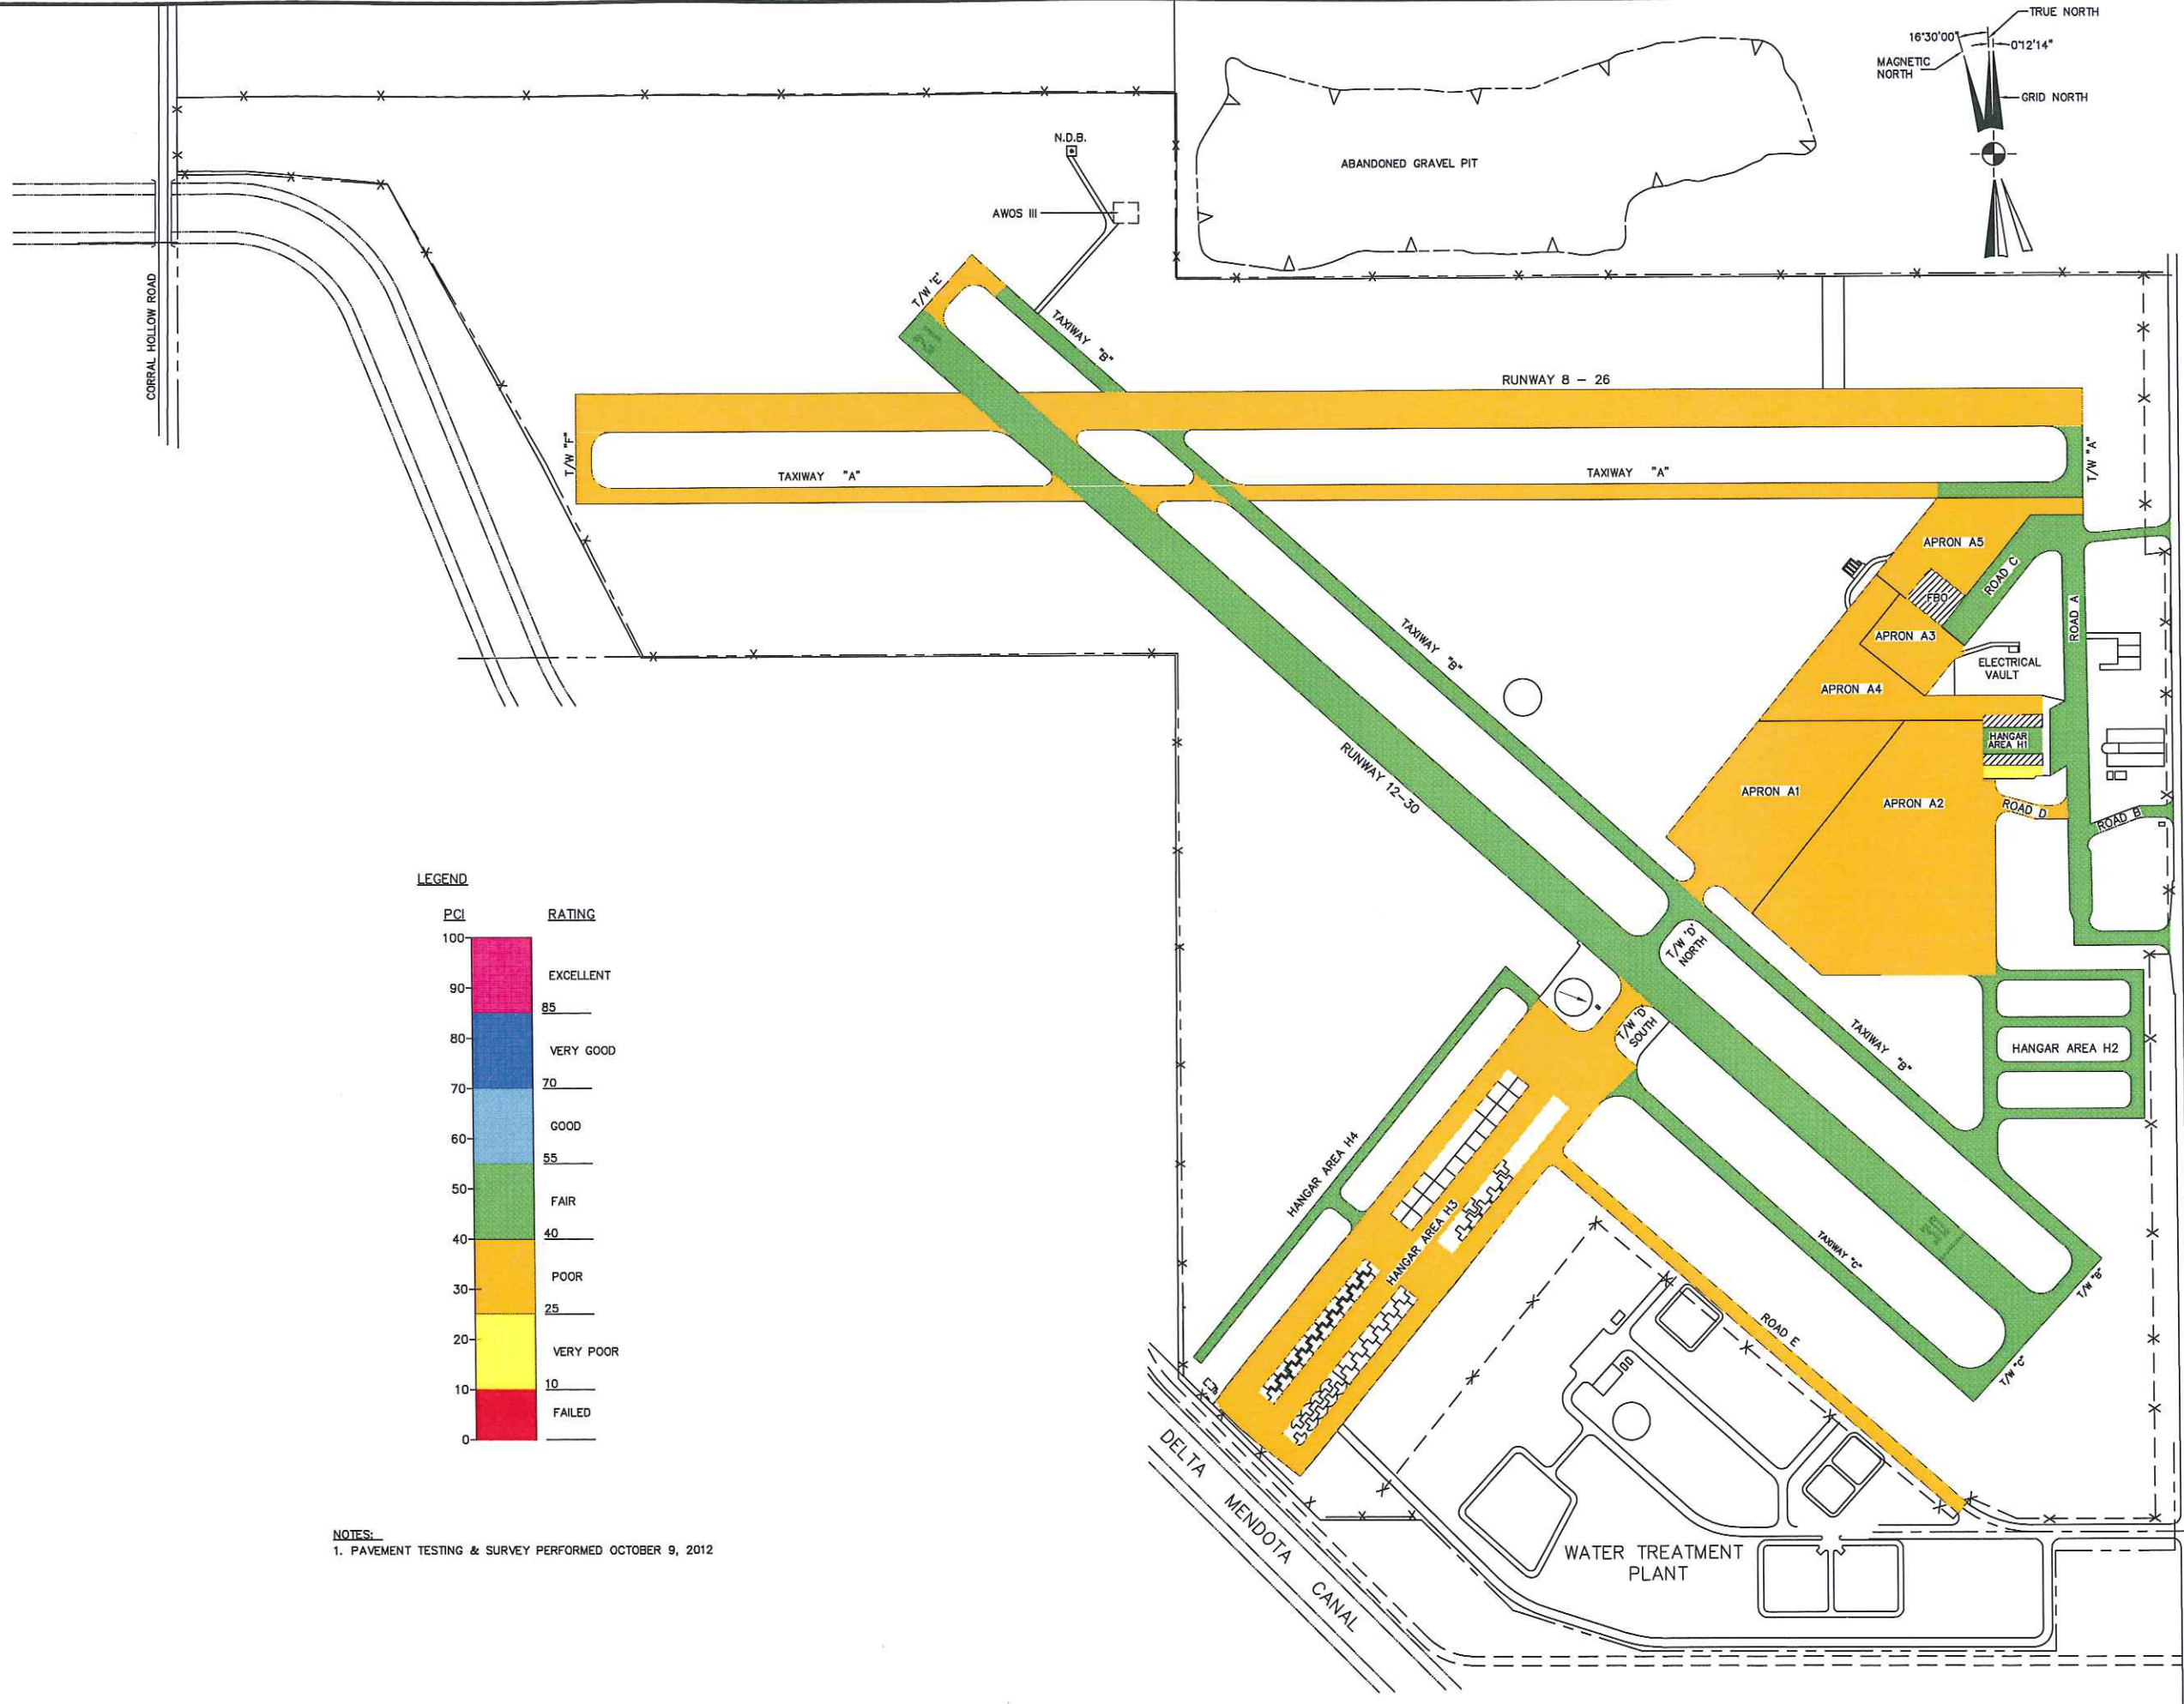
As an aid in determining the performance to date of the existing pavements and to provide a guide for the test program to be conducted in this study a detailed condition survey of all existing pavements was made. This survey consisted of visually observing all pavements and noting deficiencies in areas of distress. A drawing identifying the pavements surveyed is included in this appendix as Plate No. C1. Plate No. C2 gives the stationing control for all segments of pavement included in this report. A drawing indicating the PCI (Pavement Condition Index) rating of each segment of pavement by color is included as Plate No. C3.
