**TRACY MUNICIPAL AIRPORT
PAVEMENT EVALUATION STUDY
PAVEMENT MAINTENANCE/MANAGEMENT PLAN**

*Prepared for
City of Tracy, California*

*Prepared by:
Reinard W. Brandley
Consulting Airport Engineer*

March 2013

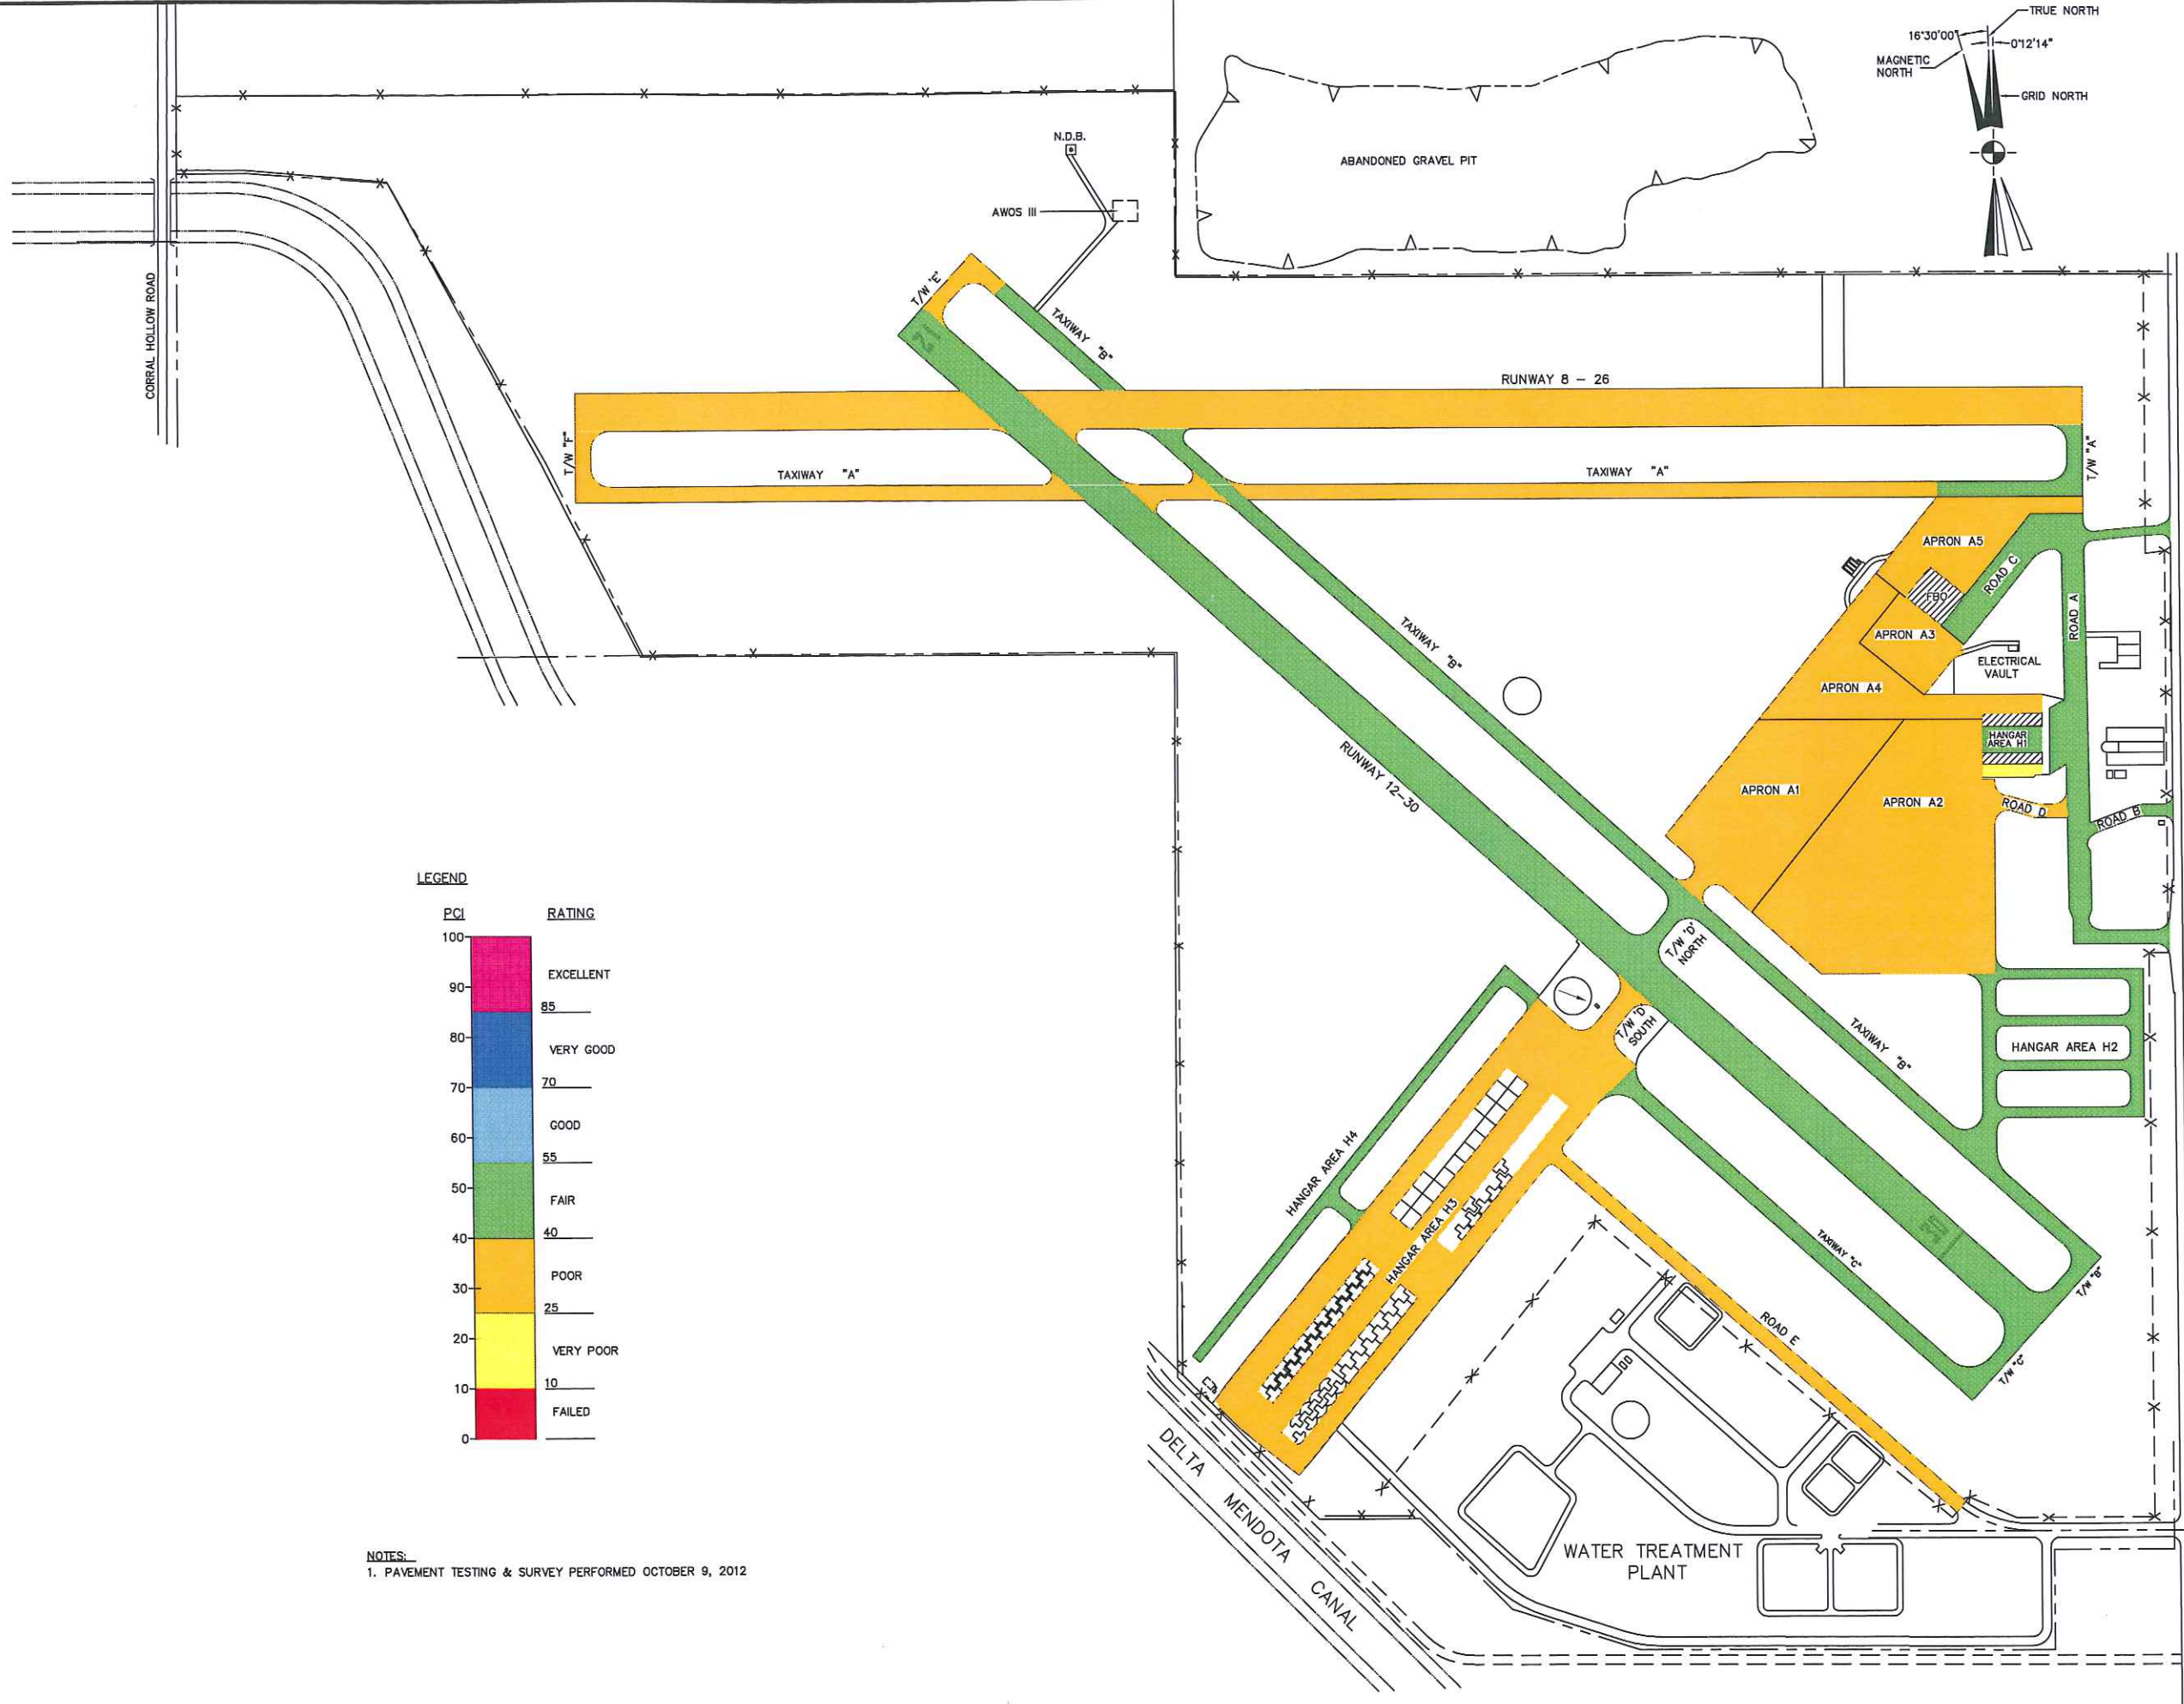
DESIGN BY: DB
 DRAWN BY: DB
 CHKD BY: RWVB
 DATE: MARCH 11, 2013
 CONTRACT No. -
 PROJECT NO: 51.04-13
 DWG FILE: -
 DRAWING SCALE: 1"=200'
 SHEET NUMBER
 PLATE No. 2-1

The ASTM Standard provides a relationship between Pavement Condition Index (PCI) and pavement rating. On Plate No. 2-1 the rating system is indicated as a color legend and the rating of each segment of pavement is indicated by color. The PCI of each segment is also indicated adjacent to each segment of the pavement. It will be noted that most pavements at the airport range from the "poor" to "fair" condition. Most pavements are showing significant raveling of the slurry seals and asphalt surfaces. They also have cracked asphalt beneath the slurry seals that are reflecting through to the surface. As a result of the surface conditions on most of the pavements, most rehabilitation is recommended earlier than the forecast remaining life of the pavement.

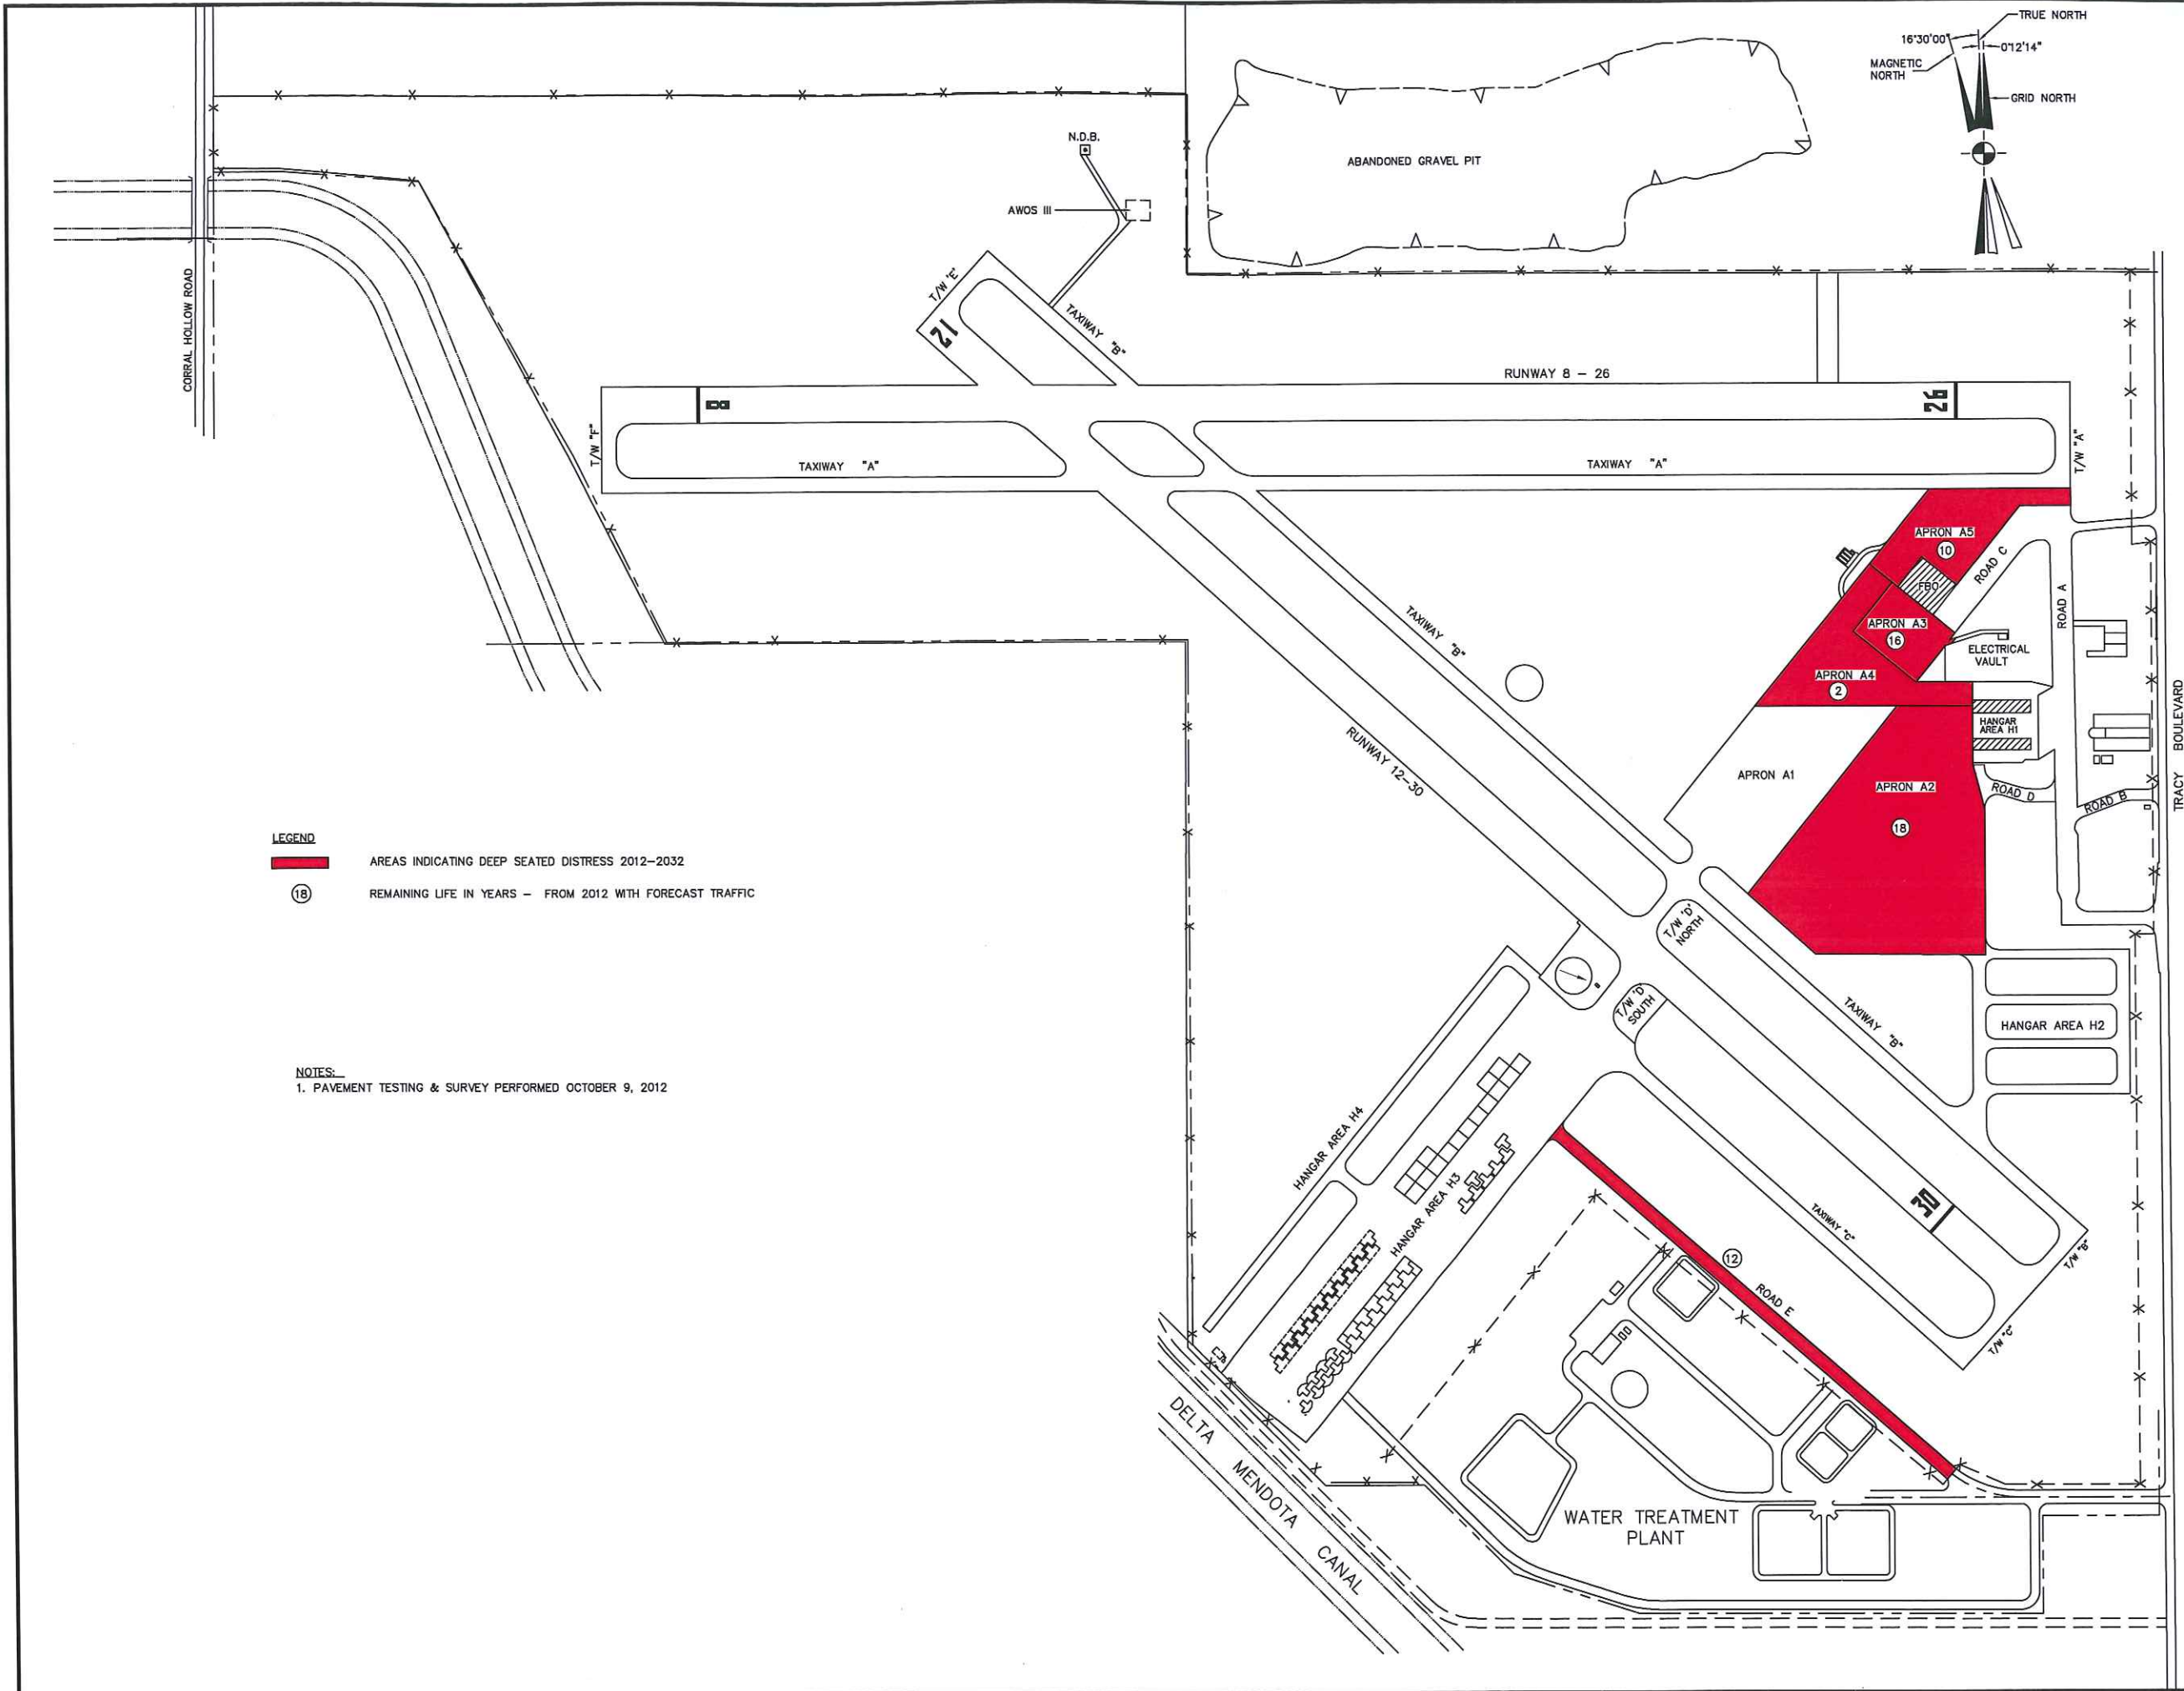
SHEET NUMBER
PLATE No. 3-1

Plate No. 3-1 indicates in color those areas on the airport that are expected to fail due to deep seated distress within a 20-year period using the BRANDLEY Fatigue Analysis with the Likely Forecast Traffic Indexes. The circled numbers next to each section indicate the remaining life in years of each section.

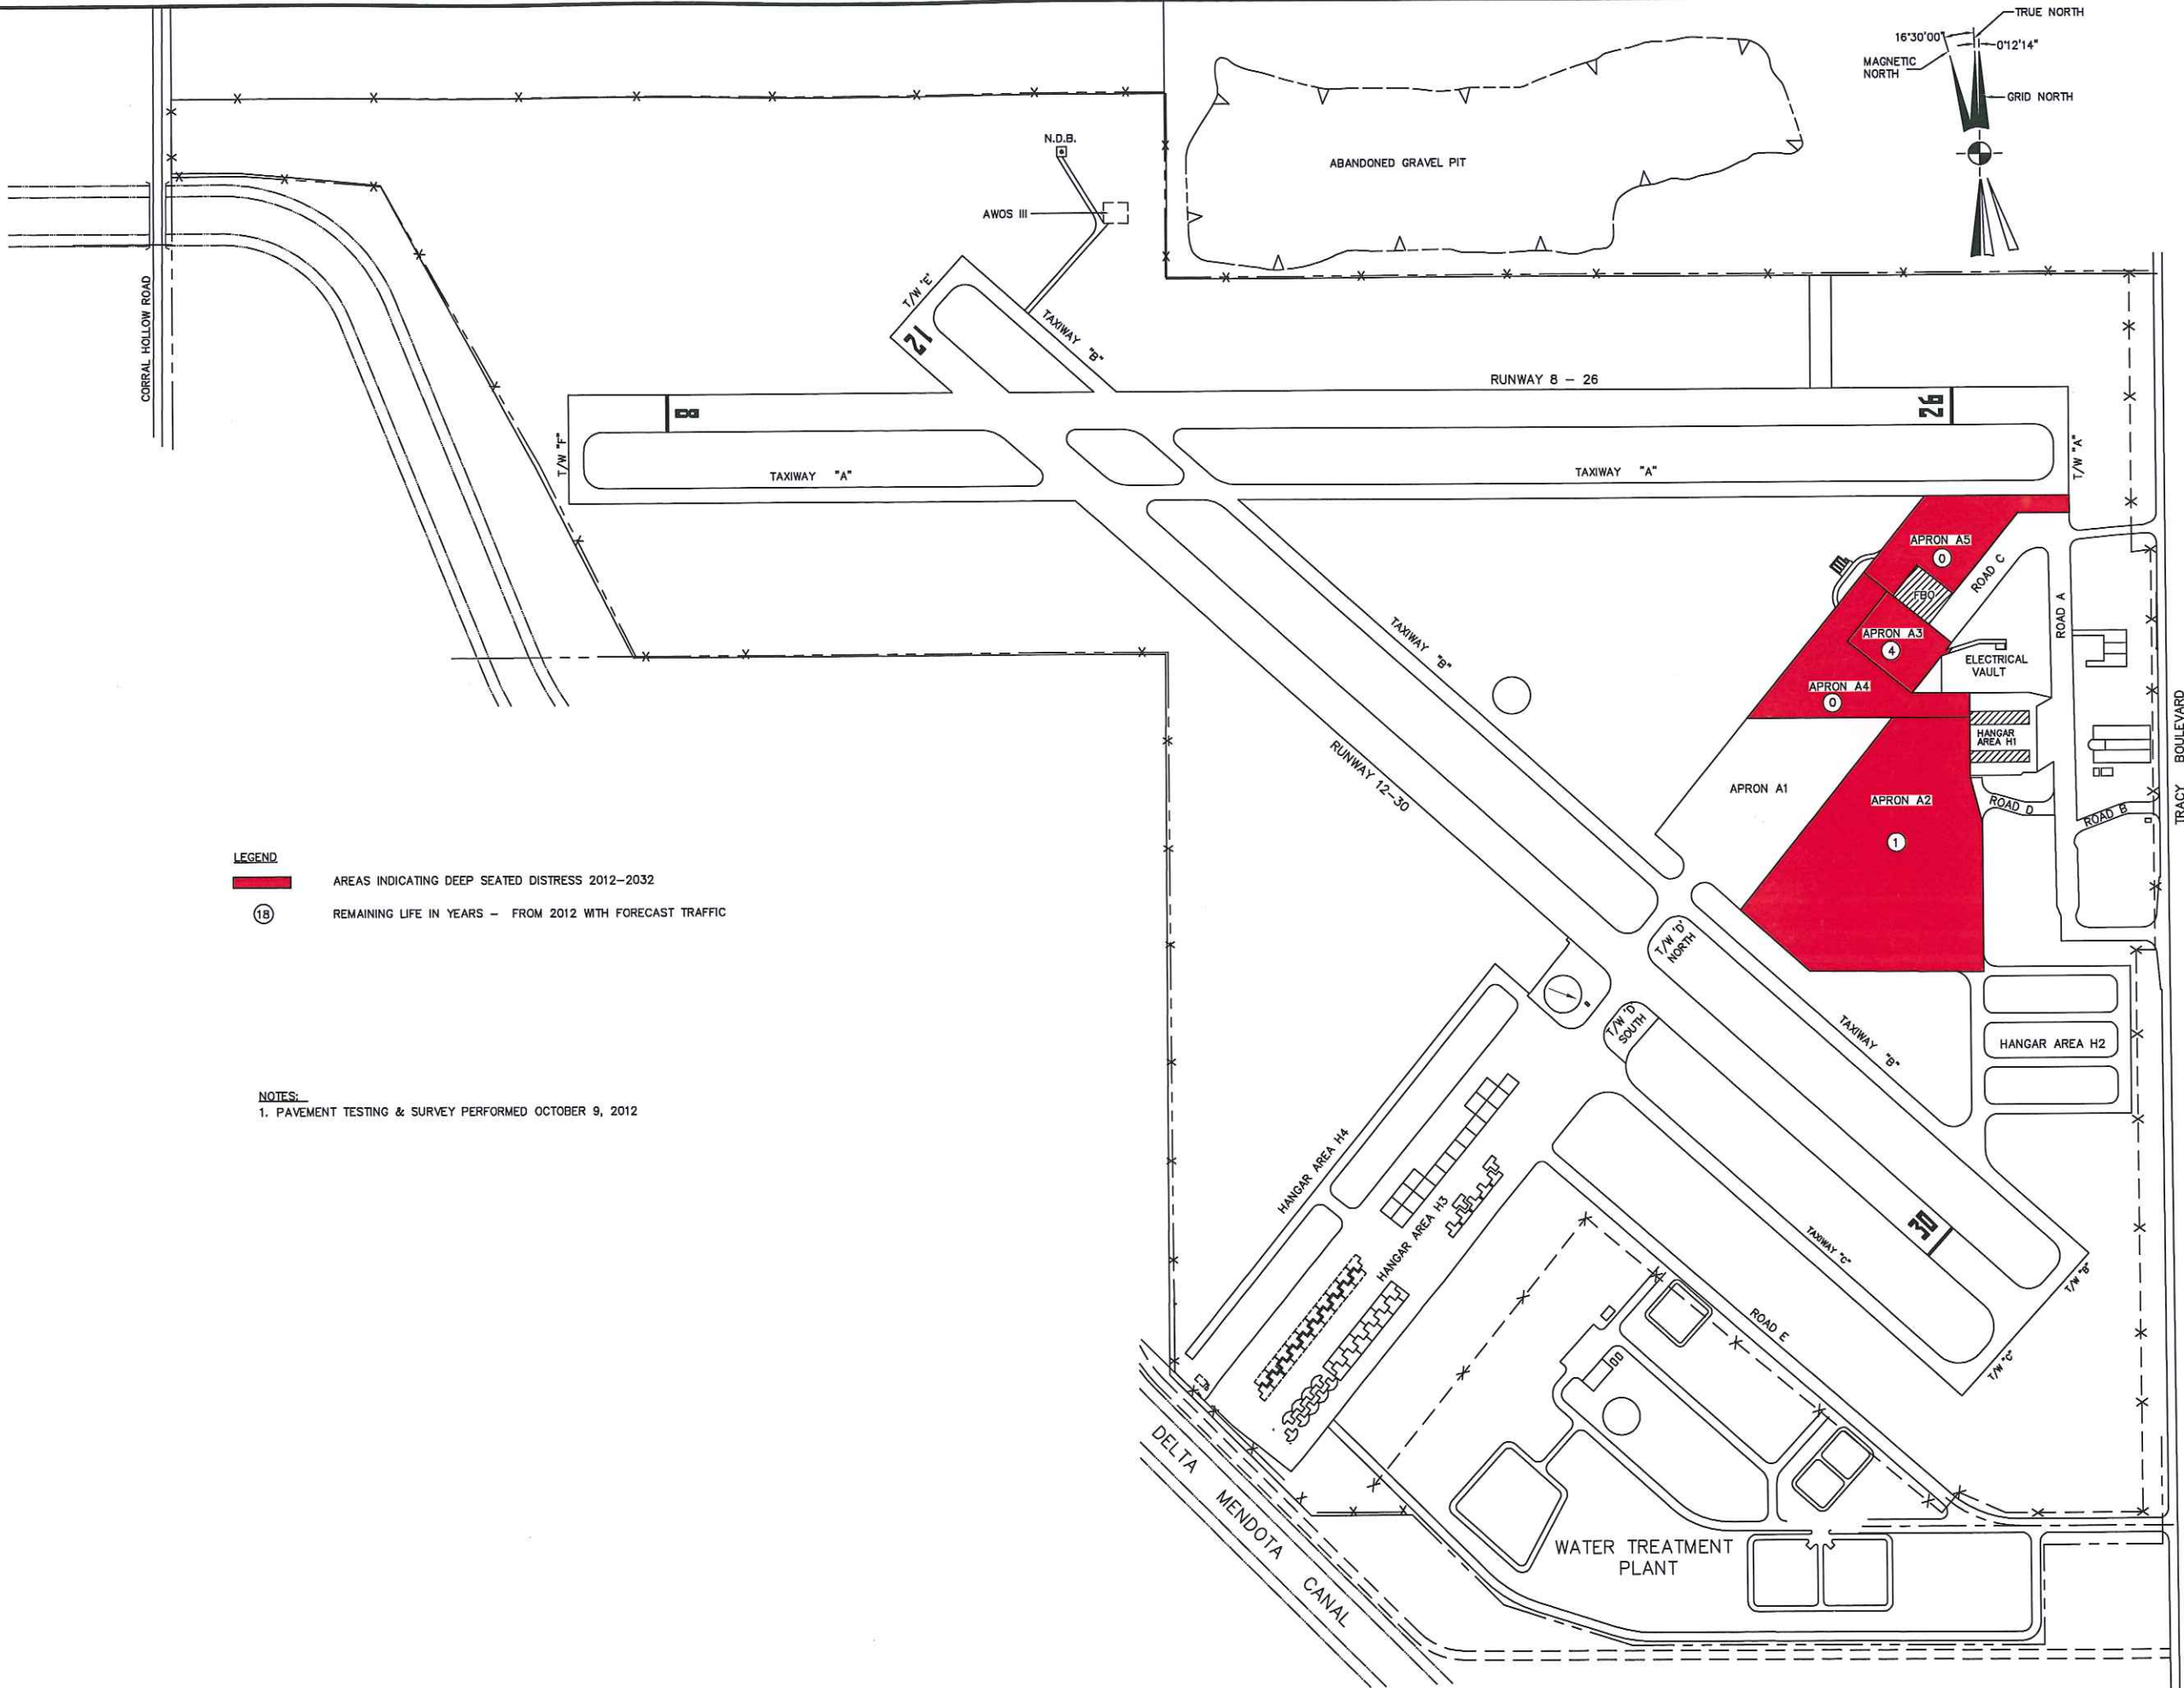
SHEET NUMBER
PLATE No. 3-2

Plate No. 3-2 indicates in color those areas on the airport that are expected to fail due to deep seated distress within a 20-year period using the FAARFIELD analysis with the Likely Forecast Traffic Indexes. The circled numbers next to each section indicate the remaining life in years of each section.

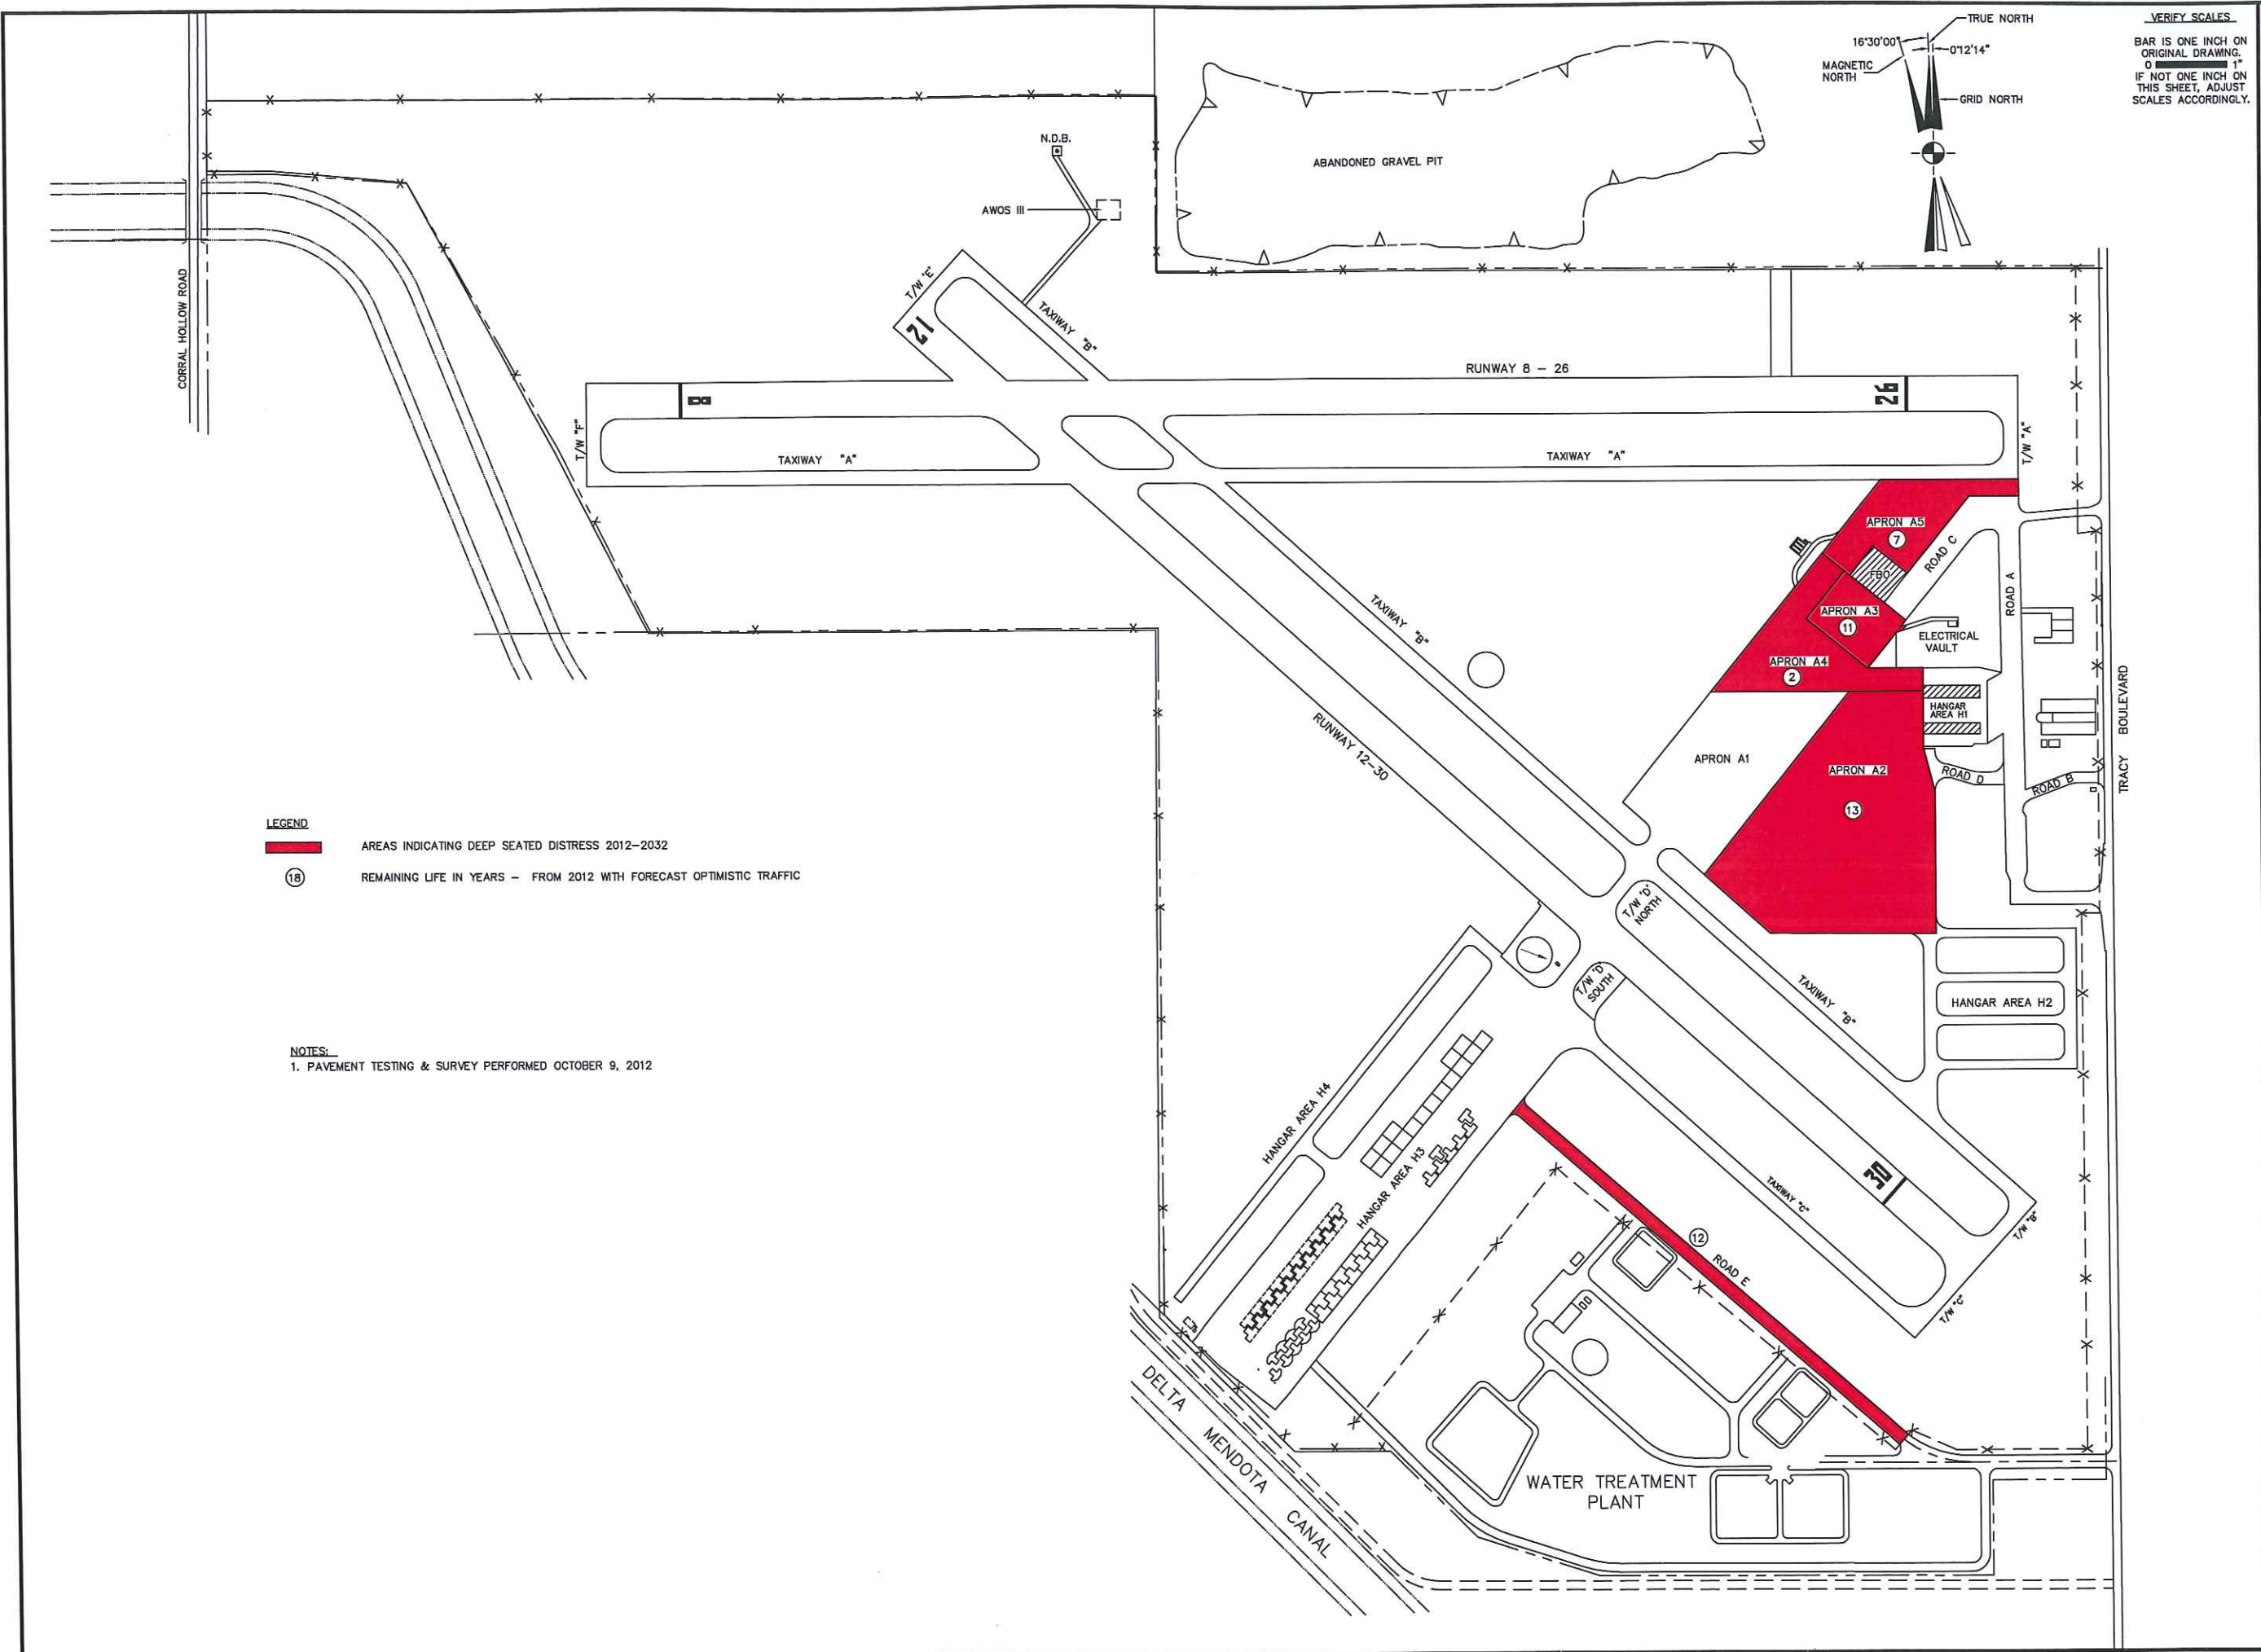
DESIGN BY: DB
 DRAWN BY: DB
 CHKD BY: RWB
 DATE: MARCH 11, 2013
 CONTRACT No. -
 PROJECT NO: 51.04-13
 DWG FILE: -
 DRAWING SCALE: 1"=200'
 SHEET NUMBER
 PLATE No. 3-3

Plate No. 3-3 indicates in color those areas on the airport that are expected to fail due to deep seated distress within a 20-year period using the BRANDLEY Fatigue Analysis with the Optimistic Traffic Indexes. The circled numbers next to each section indicate the remaining life in years of each section.

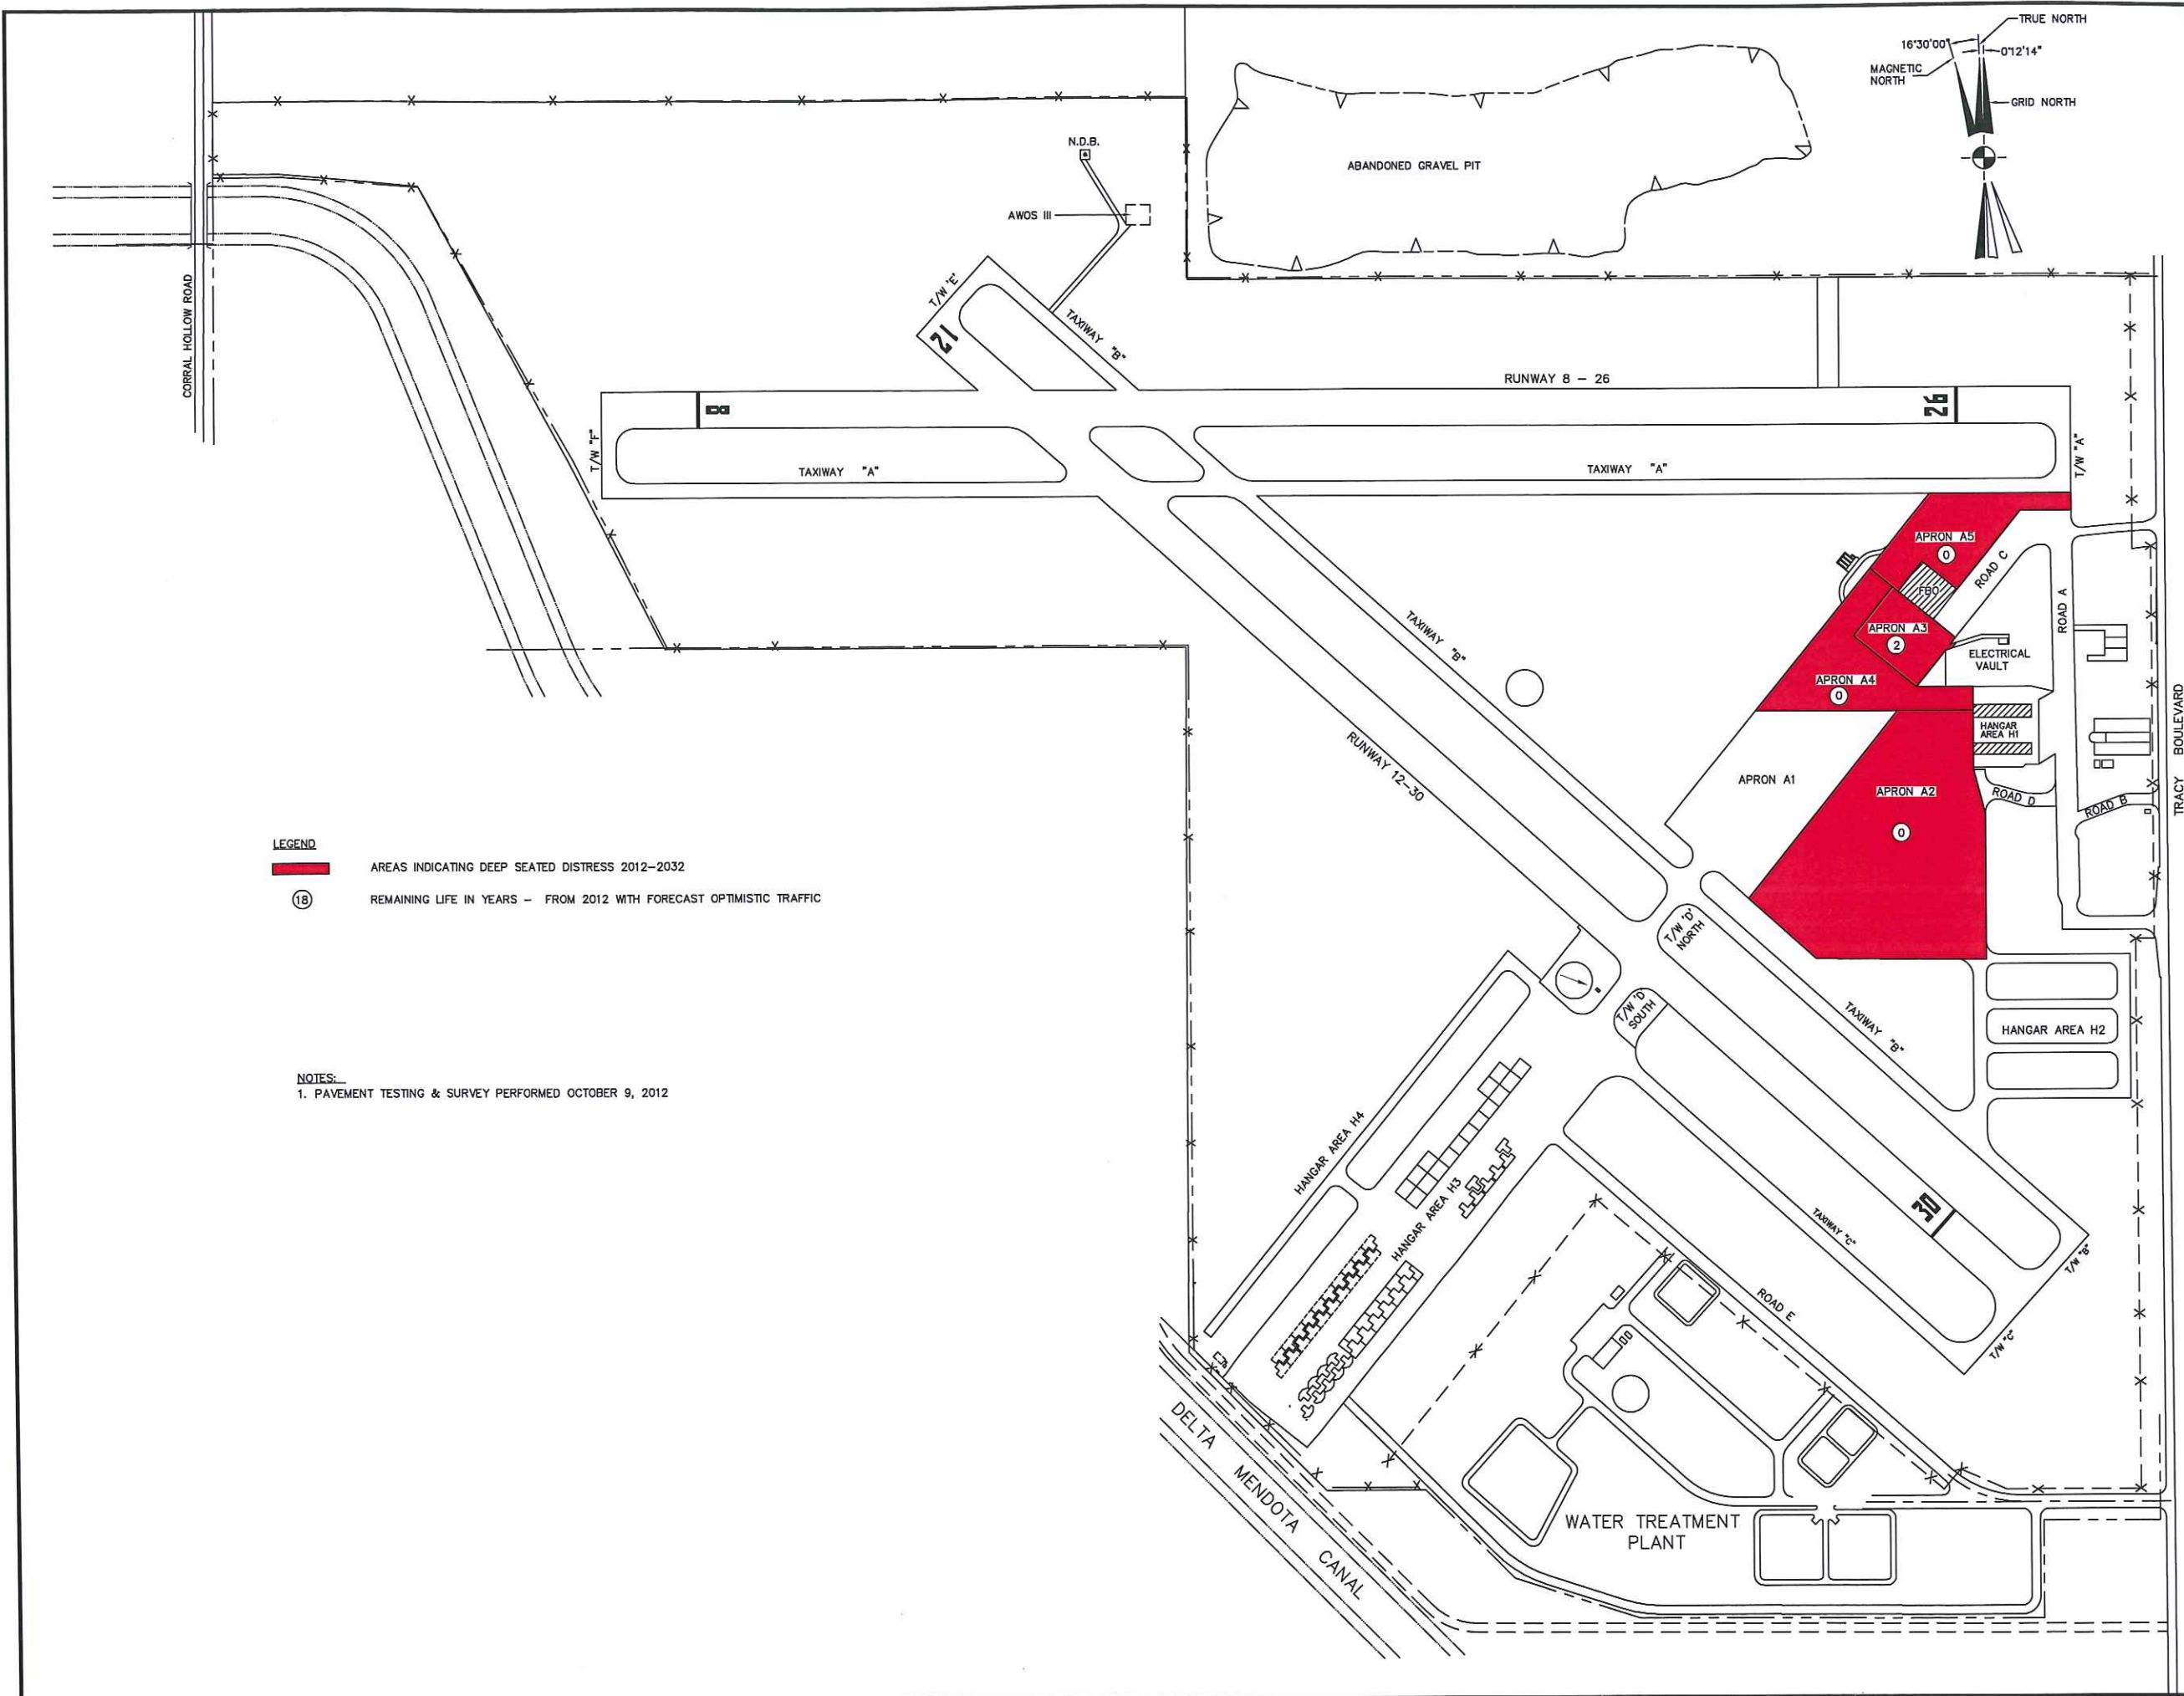
DESIGN BY: DB
 DRAWN BY: DB
 CHKD BY: RVVB
 DATE: MARCH 11, 2013
 CONTRACT NO.: -
 PROJECT NO: 51.04-13
 DWG FILE: -
 DRAWING SCALE: 1"=200'
 SHEET NUMBER
 PLATE No. 3-4

Plate No. 3-4 indicates in color those areas on the airport that are expected to fail due to deep seated distress within a 20-year period using the FAARFIELD analysis with the Optimistic Traffic Indexes. The circled numbers next to each section indicate the remaining life in years of each section.

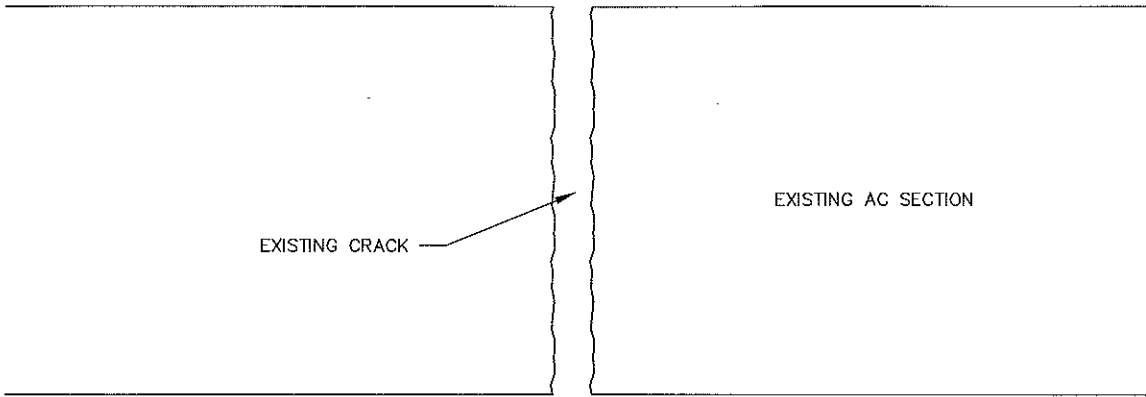
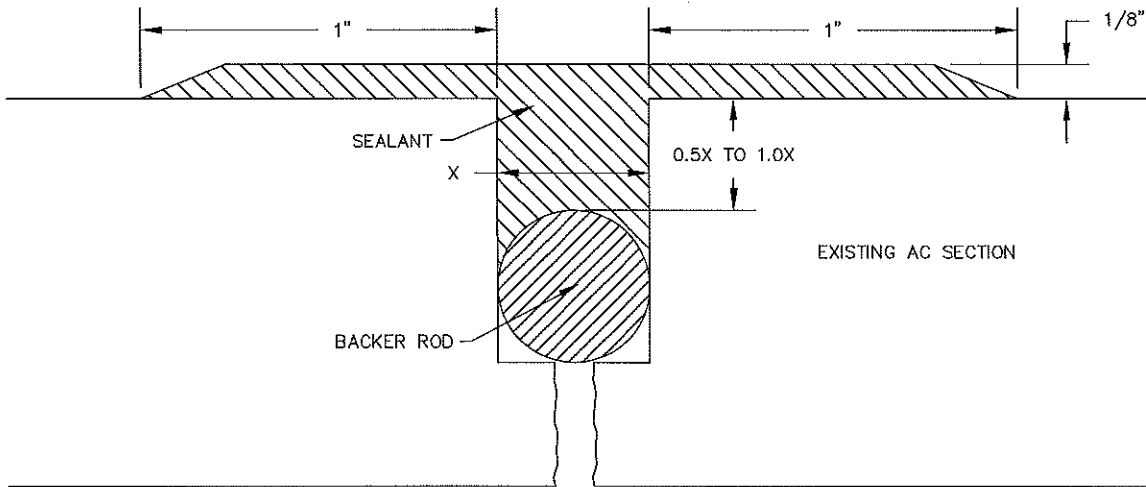
Surface cracking can be caused by thermal stresses in the pavement. These stresses are created by large changes in temperature of the pavement from day to night and summer to winter. Over time these temperature variations combined with the oil in the asphalt becoming old and brittle can cause cracking of the asphalt pavement.

Sealing of the cracks is an important maintenance procedure since it resists spalling or raveling of the pavement immediately adjacent to the cracks and inhibits the entry of storm water into the underlying aggregate base course. Normal crack sealing operations, including filling the crack with sealant and/or adding a "Band Aid" section of sealant on top of the crack will have limited life. It is recommended that all cracks to be sealed be prepared for sealing by routing a section to provide a depth to width ratio of the sealant of no more than 1 to 1. This will also require the installation of a backer rod below the sealant to keep the sealant from filling the bottom section of the crack. The sealant should include a "Band Aid" on the top of the pavement over the seal extending 1-inch minimum beyond the edge of the prepared repair on each side of the crack. The thickness of the "Band Aid" should be 1/8". A typical section of a crack seal repair is shown on Plate 3-6.
