**TRACY MUNICIPAL AIRPORT
PAVEMENT EVALUATION STUDY
PAVEMENT MAINTENANCE/MANAGEMENT PLAN**

*Prepared for
City of Tracy, California*

*Prepared by:
Reinard W. Brandley
Consulting Airport Engineer*

March 2013

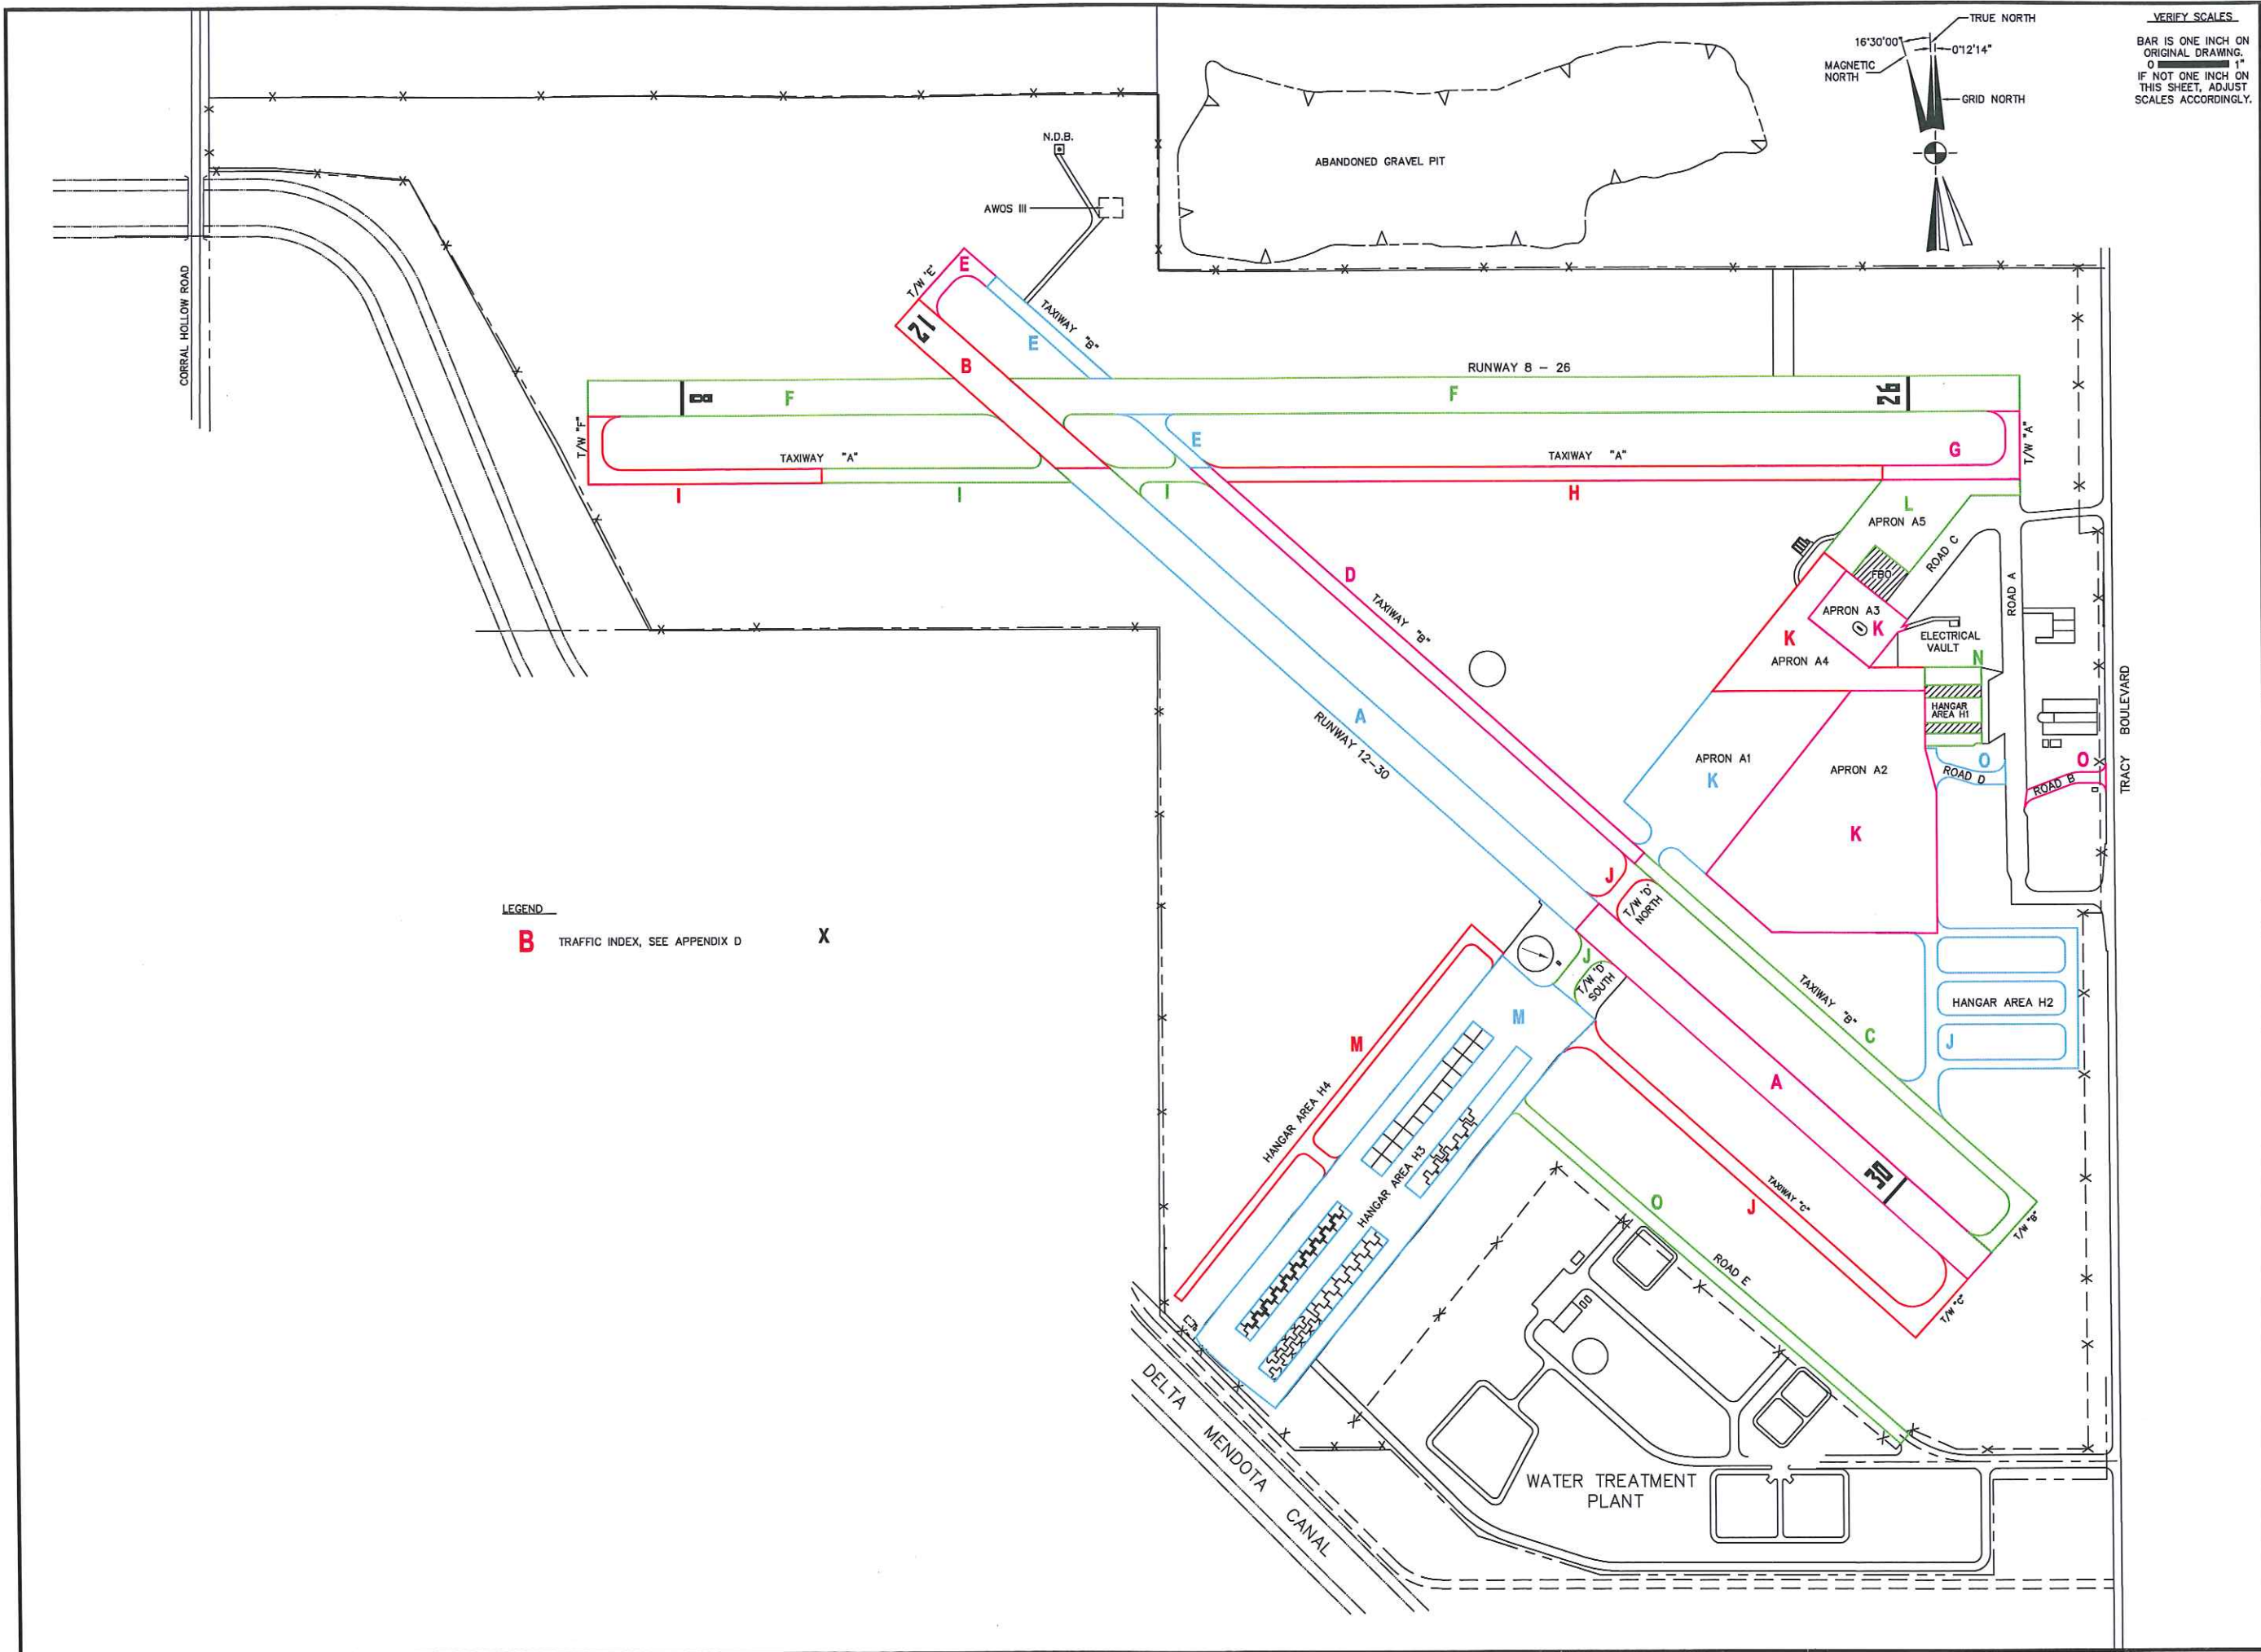
DESIGN BY: DB
 DRAWN BY: DB
 CHKD BY: RWVB
 DATE: MARCH 11, 2013
 CONTRACT No. -
 PROJECT NO: 51.04-13
 DWG FILE: -
 DRAWING SCALE: 1"=200'
 SHEET NUMBER
 PLATE No. 2-1

The ASTM Standard provides a relationship between Pavement Condition Index (PCI) and pavement rating. On Plate No. 2-1 the rating system is indicated as a color legend and the rating of each segment of pavement is indicated by color. The PCI of each segment is also indicated adjacent to each segment of the pavement. It will be noted that most pavements at the airport range from the "poor" to "fair" condition. Most pavements are showing significant raveling of the slurry seals and asphalt surfaces. They also have cracked asphalt beneath the slurry seals that are reflecting through to the surface. As a result of the surface conditions on most of the pavements, most rehabilitation is recommended earlier than the forecast remaining life of the pavement.

TRACY MUNICIPAL AIRPORT
 CALIFORNIA
PAVEMENT EVALUATION
 SURFACE DISTRESS - PAVEMENT CONDITION INDEX (PCI)
